GAGE HALL CLOSURE REPORT

The State University of New York College @ New Paltz Campus Route 32. New Paltz, NY 12561

Clean Harbors Environmental Services, Inc. Albany Service Center 32 Bask Road Glenmont, NY 12077

June 1, 1993

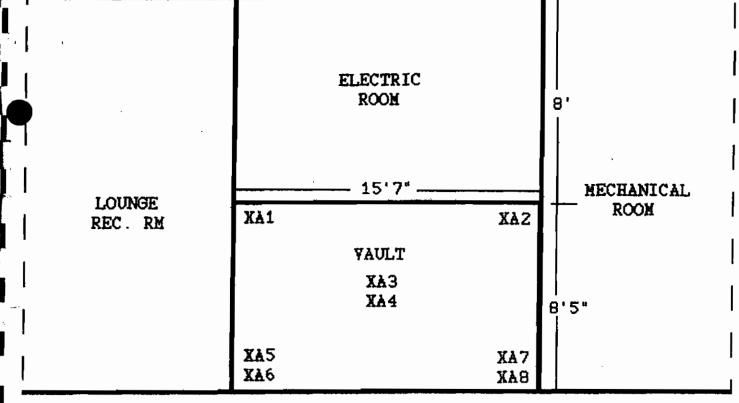
GAGE VAULT EXCAVATION GRID-DEPTH 1'6" BELOW T.O.S. PCB SAMPLES COLLECTED 6/5/92.

LOCATION	DEPTH (FEET)	RESULTS mg/kg	
A1	2'6"	ND	KEY
A 2	2'6"	4.2	mg/kg = milligra
¥3	2'6"	23.0	ND = NON-DETECT
λ4	3,	1.1	T.O.S. = TOP OF
A 5	2'-3'	24.0	
A 6	3'-4'	2.7	
À7	2'-3'	ND	Nome
A8	3'-4'	ND	NOTE:
			ALL SAMPLES W

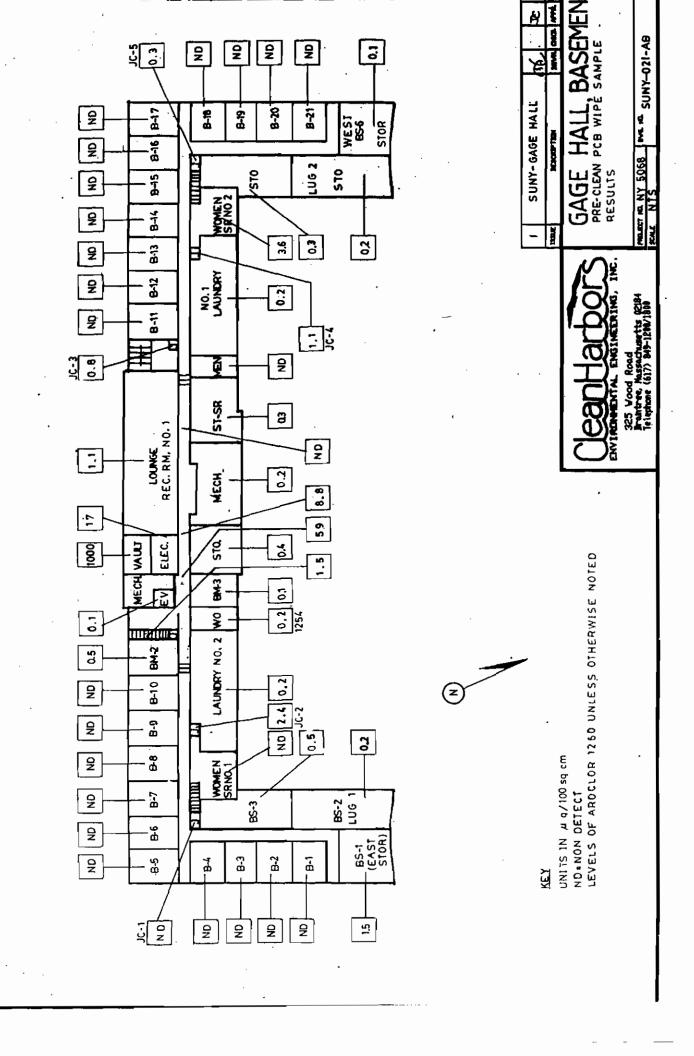
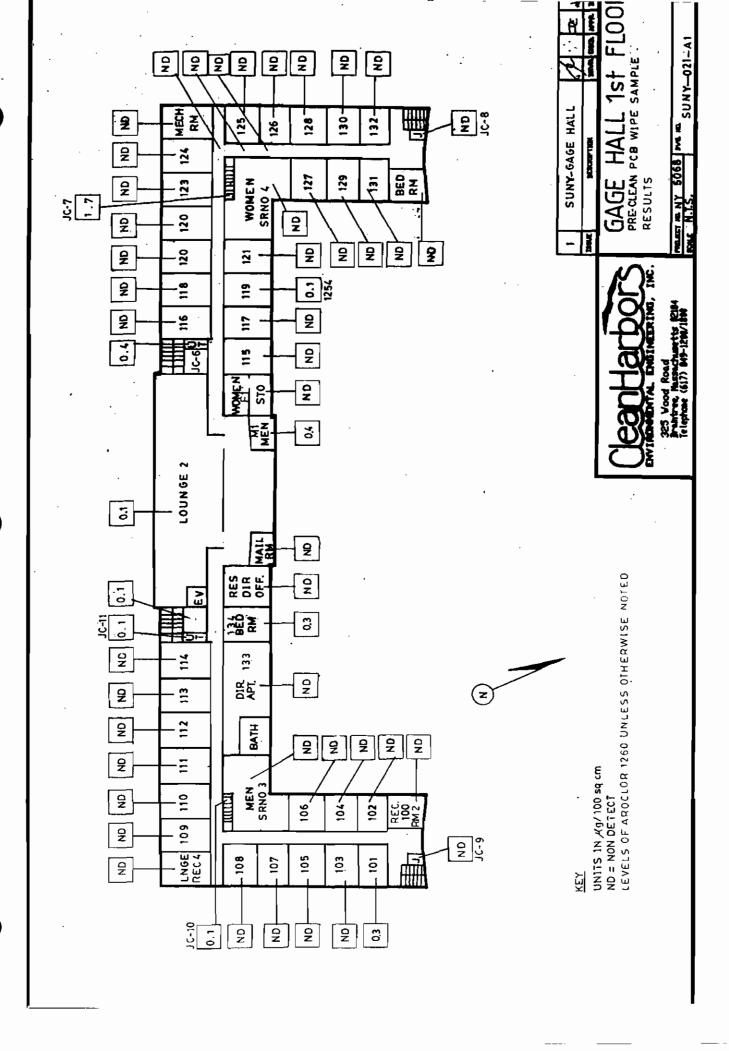
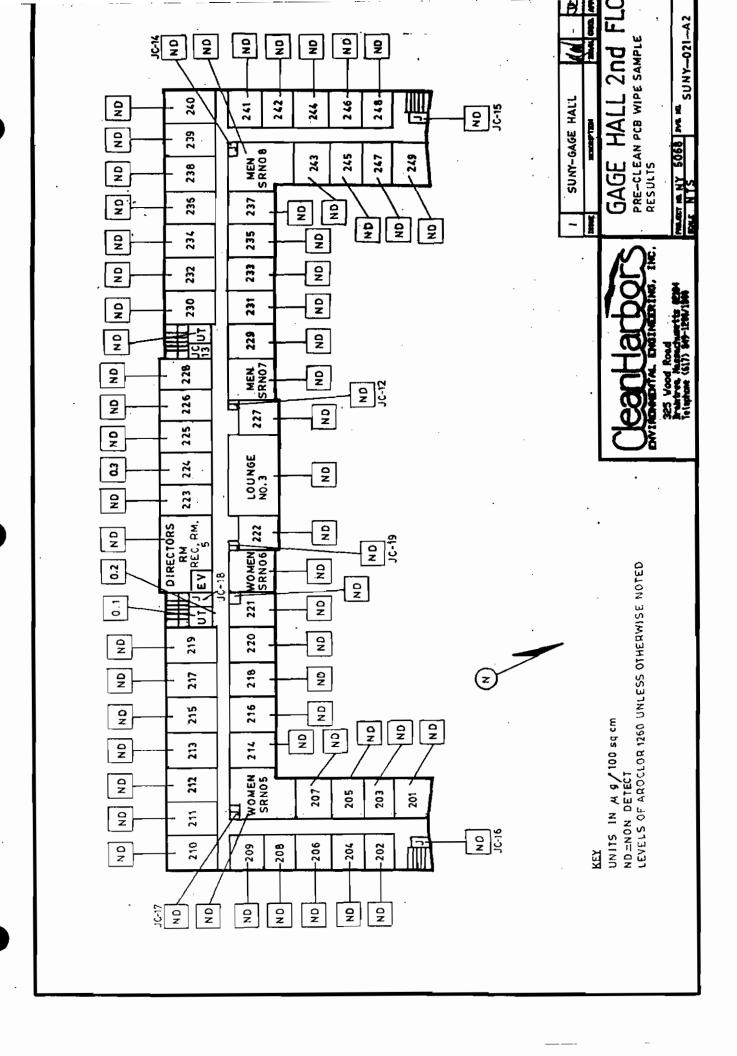
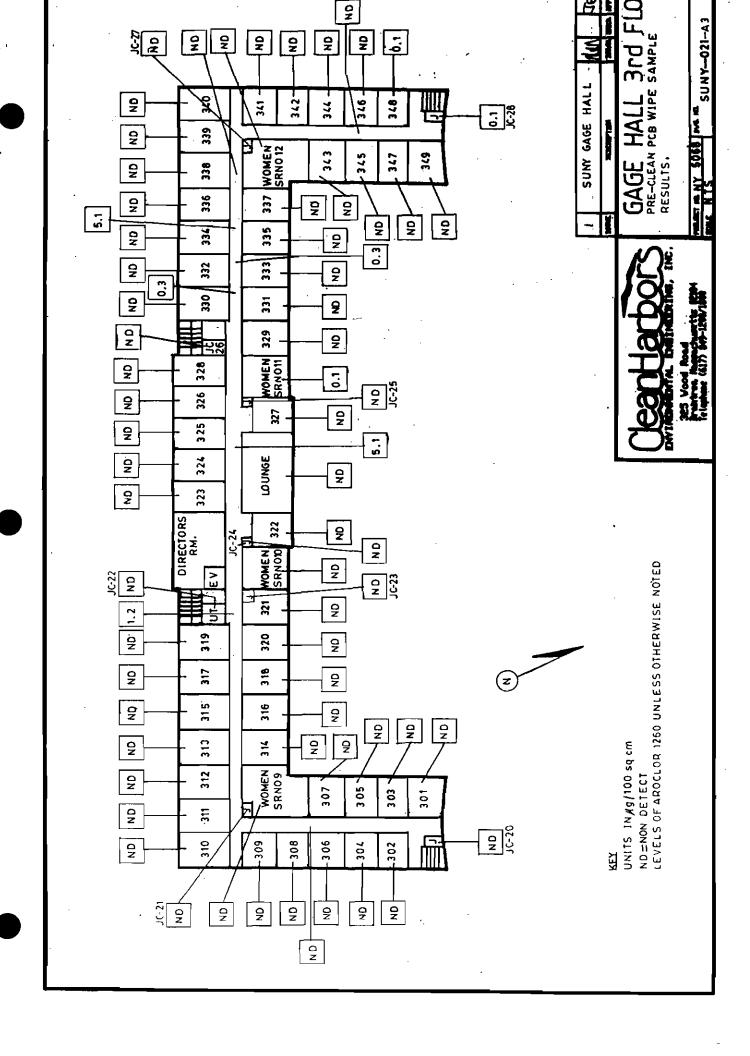
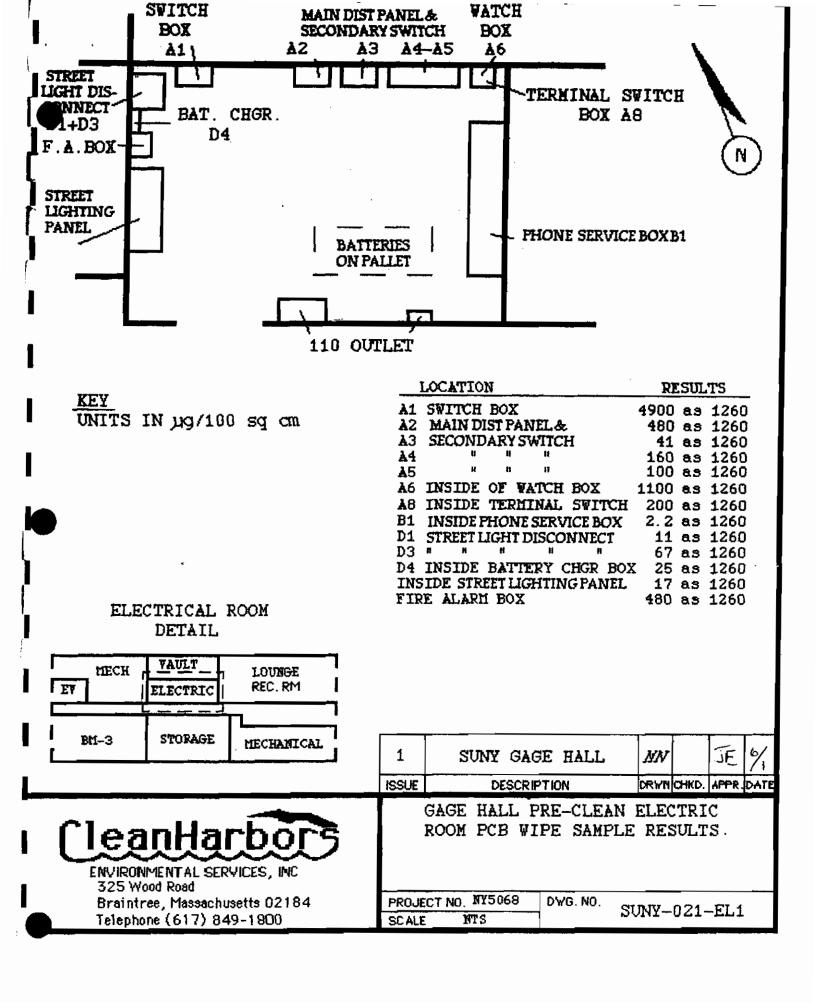
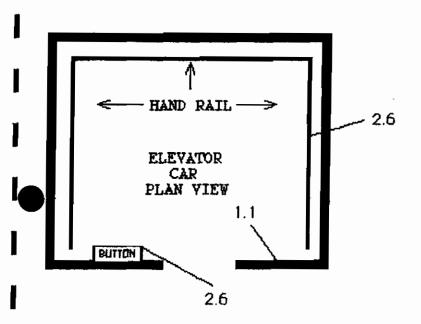
GAGE PRE-CLEAN PCB WIPE SAMPLE RESULTS

SHAFT						
3rd FLOOR	0.7					
2nd FLOOR	2.2					
1st FLOOR	0.1

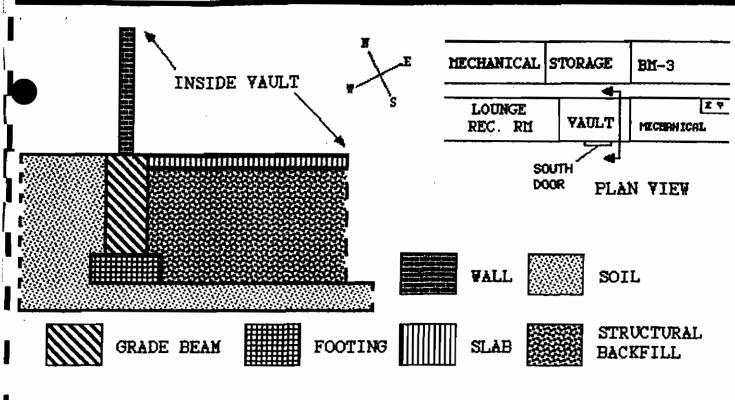
GAGE VAULT PCB WIPE SAMPLE RESULTS

With the exception of approximately seventy (70) square feet of the South wall and grade beam in the vault, all areas within Gage Hall have been remediated to the EPA and UCDOH re-occupancy criteria. The contaminated surfaces have been encapsulated and sealed off with a polyethylene barrier. The Ulster County Department of Health recommended in February 1992 that all Student Rooms and public access areas, not including the elevator and the Recreation Room, be opened for general admission (See Appendix A - 10). In August 1992, the UCDOH extended the opening to include the elevator.

SOUTH WALL	NORTH WALL	EAST WALL	WEST WALL	CEILING	SOUTH GRADE BE	SOUTH AM DOOR
16	26	56	24	1.0	41	32
46	64	58	20		140	
22 (WEST	HALF OF WALL)				4 50 (C	HIP)*
26 (WEST	HALF OF WALL)				940 (C	HIP)*
40 (EAST	HALF OF WALL)					
21 (EAS	HALF OF WALL)

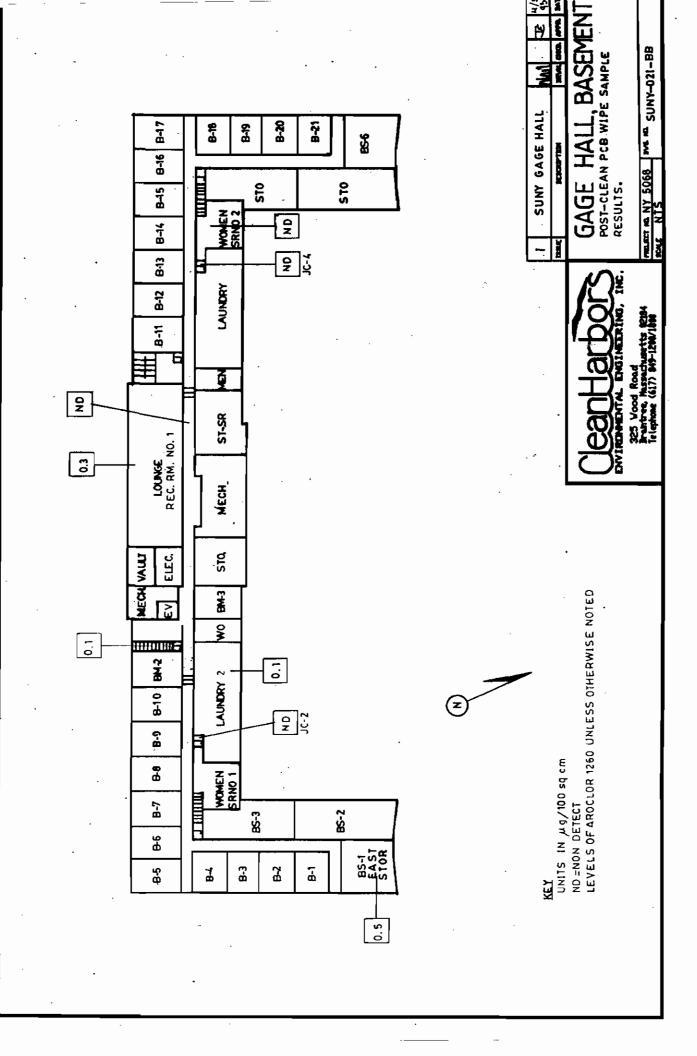
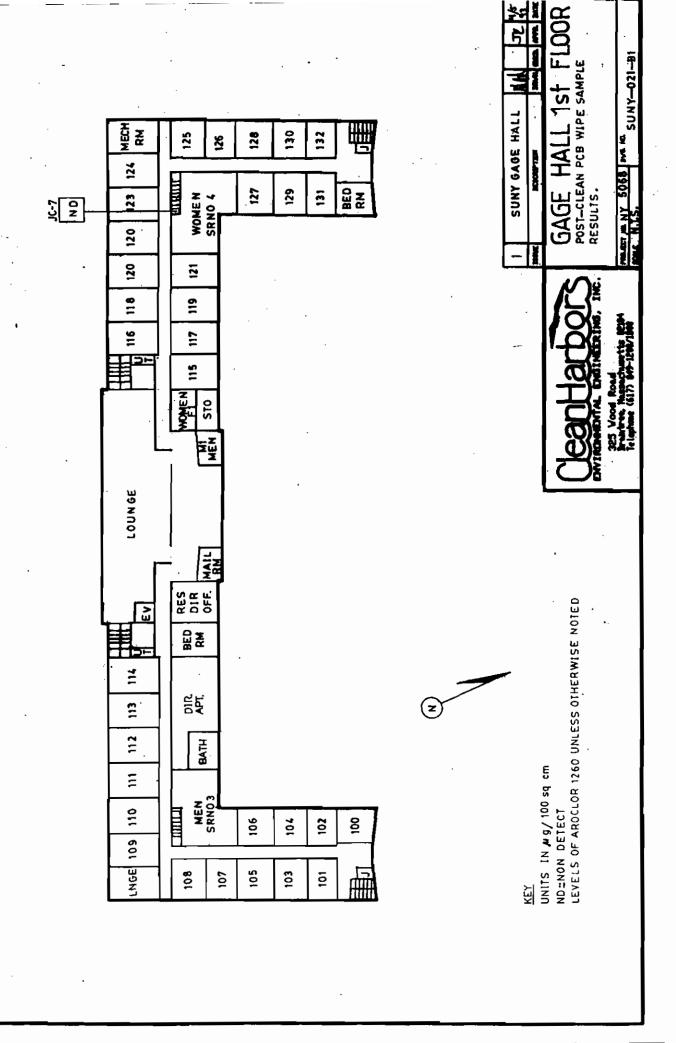
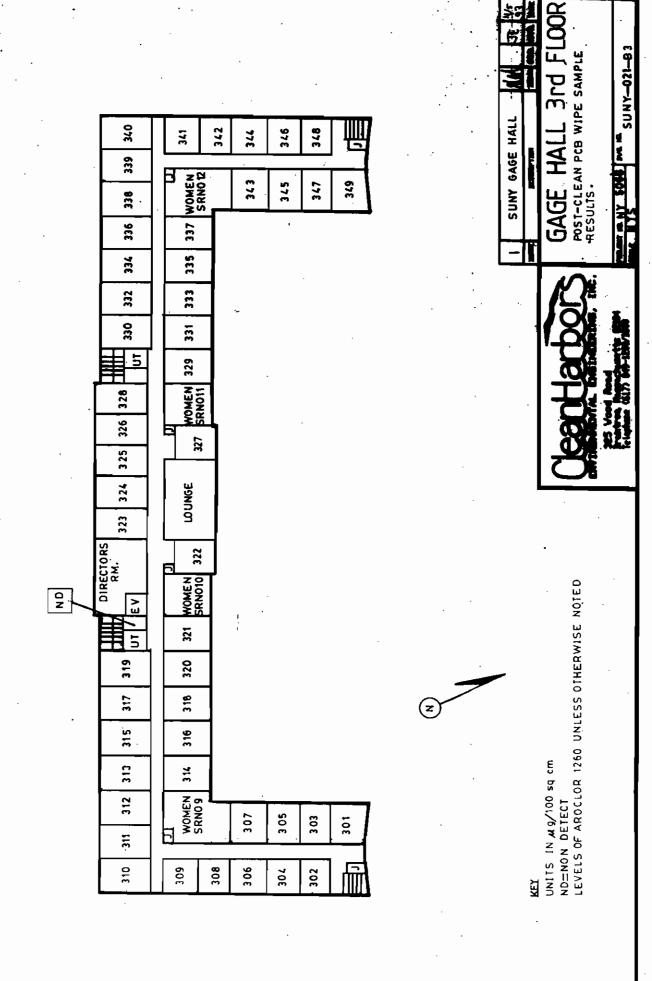
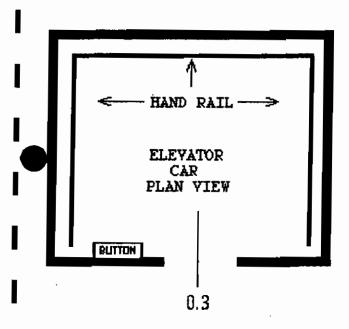
GAGE POST-CLEAN PCB WIPE SAMPLE RESULTS

3rd FLOOR 0.7 2nd FLOOR 0.3 1st FLOOR 0.3
