SUBJECT: PCB Monitoring Program

TO: Arnold Bernardini, Assistant Vice President Facilities & Planning
FROM: Peter Betley, Coordinator Environmental Health and Safety
DATE: March 25, 1997
RE: Ground Water Testing - PCBs

RE: **GROUND WATER TESTING-PCB's**

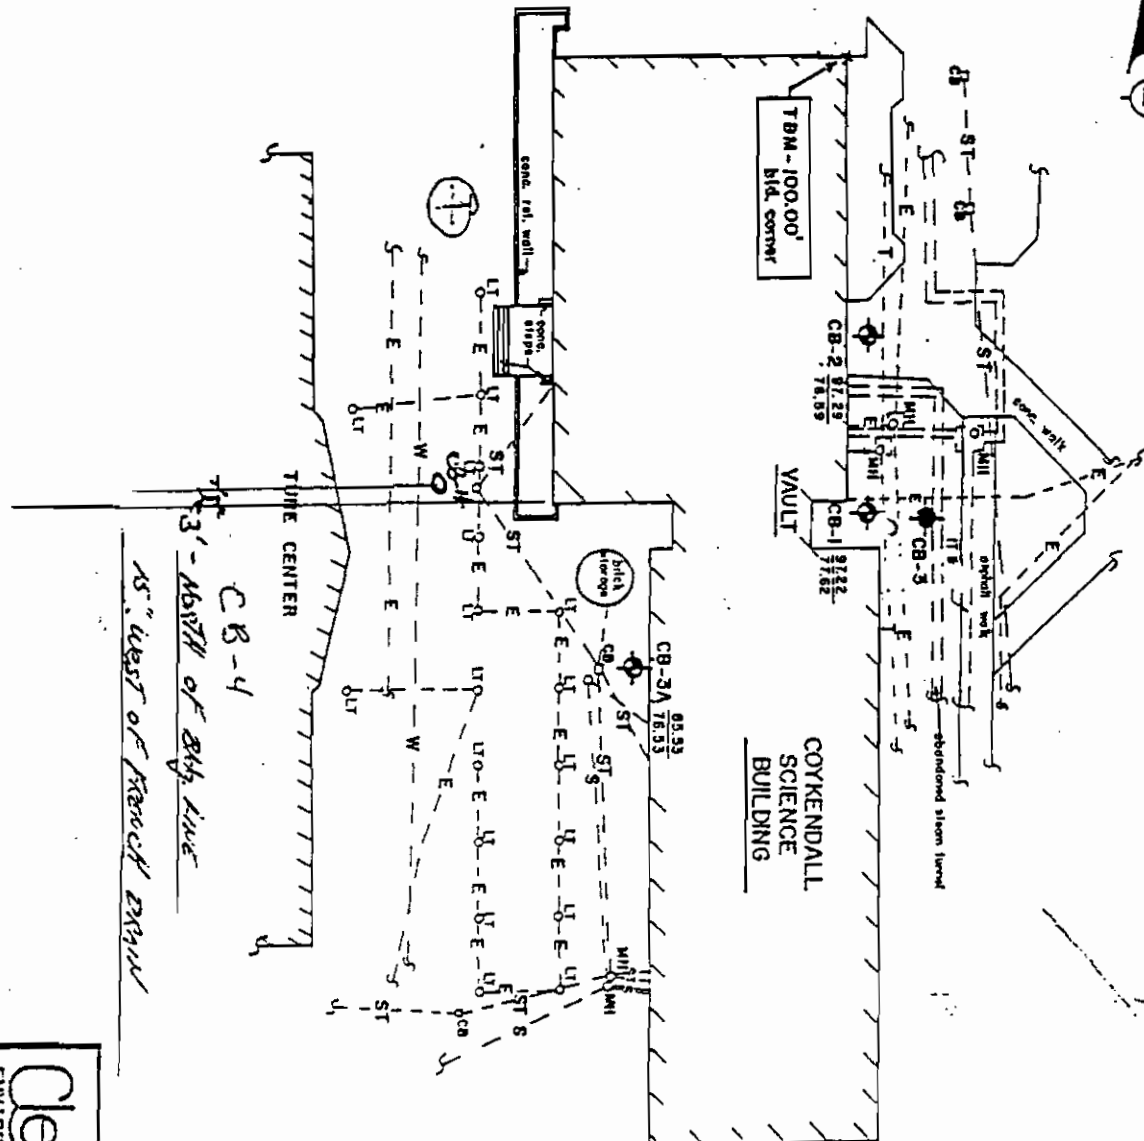
A	PRELIMINARY	DATE	BY
	PROJECT NO.	DATE	BY
SUNY NEW PALTZ NEW PALTZ, NY COYKENDALL SCIENCE BUILDING BORING LOCATION PLAN		PROJECT NO. E-3300	DATE 3300-C-0
SCALE 1" = 40'

Note No well CB-3

Note Well # CB-2 Damaged
