SUBJECT: PCB Monitoring Program

TO: Arnold Bernardini, Assistant Vice President Facilities & Planning
FROM: Peter Betley, Coordinator Environmental Health and Safety
DATE: March 25, 1997
RE: Ground Water Testing - PCBs

RE: **GROUND WATER TESTING-PCB's**

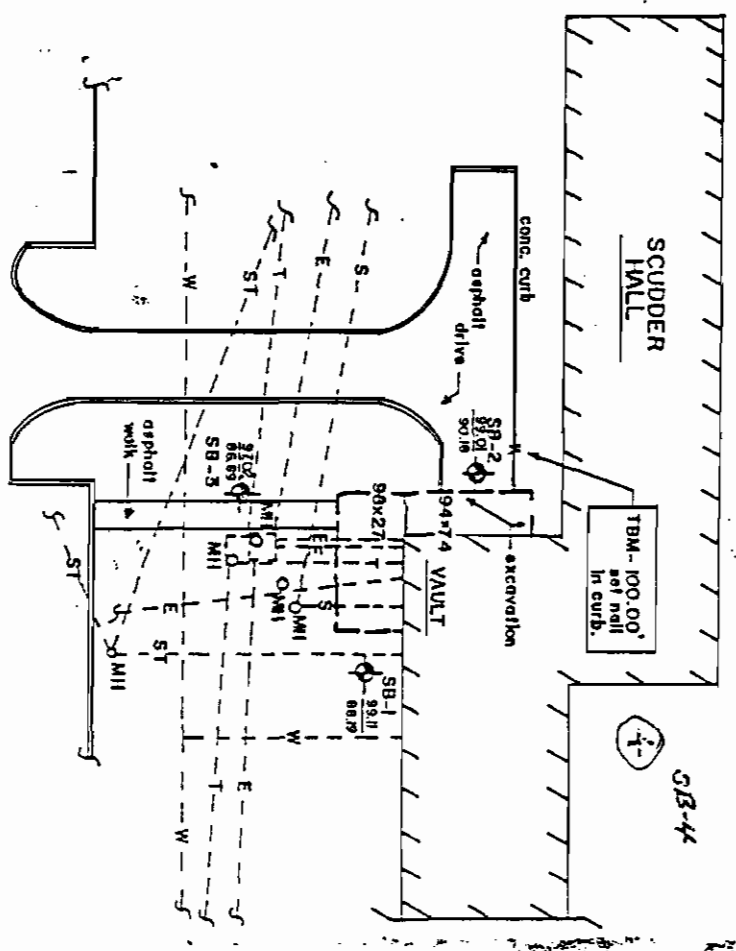
In general, the location of the wells, the depth, it should be.
